EXTERIOR

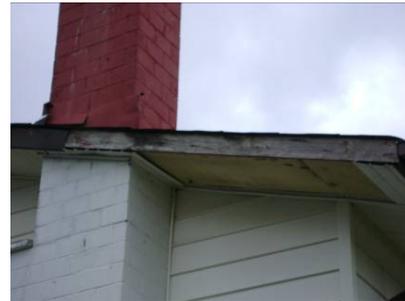
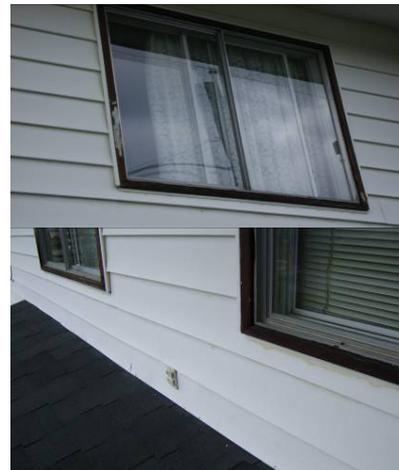
- Conditions:
 - 1- Fascia boards are covered with color painted metal and the cover in the south-west corner is missing. The visible portion of the fascia board showed wood damage due to rot.
 - 2- Soffits in the west side at the south-west corner are missing.
 - 3- Soffits in the south side at the south-west corner were not connected with the approved installation procedures (with random screw to the a base board which also showed no soffit ventilation)
 - 4- The wooden trims around windows were not well maintained, had cracks, and grains were almost visible.
 - 5- There were also some stains due to the water running under the trims over the vinyl cladding.

- *Recommendations:*
 - 1- Install the missing fascia's cover and soffits.
 - 2- Install new trims around the windows and keep them well maintained.
 - 3- Check for any hidden damages such as rot due to water penetration to the fascia and behind the cladding by a building envelope specialist.

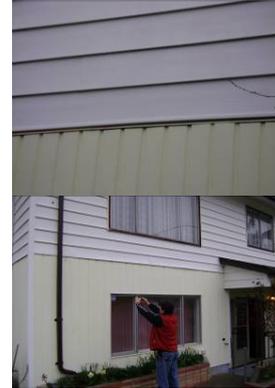
- Condition:
 - 1- Drip cap between the two applications of the siding in most of the cladding were missing which could lead to water ingress to the house.
 - 2- Most of the windows did not have appropriate flashings with the required end dams.
- *Recommendations:*
 - 1- Install drip cap between the two type applications.
 - 2- Install proper flashings over the windows to prevent water ingress behind the cladding.
 - 3- Re-seal windows and doors perimeters to prevent water ingress behind window frames.
 - 4- Check for any hidden damages due to the mentioned deficiencies.

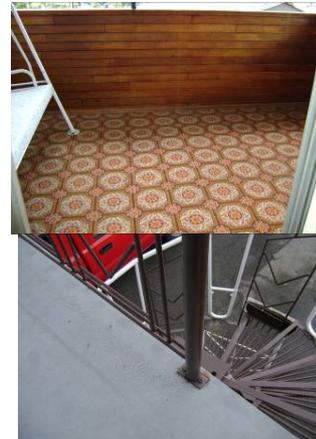
- Conditions:
 - 1- Balcony does not have drain, and it's also covered with carpet (wind rain will drop in the balcony).
 - 2- The connection of the guard's posts to the landing deck (landing for the stairs to the second floor) could cause water migration underneath.
 - 3- The entrance porch showed change in the operational procedure (due to the electrical outlet over the wall).
 - 4- Structural deficiencies will be covered in the structure section.
- *Recommendation:*
 - 1- Install proper drain and check for waterproof membrane or indoor outdoor carpet covering.
 - 2- Investigate for probable hidden damages by a specialist due to the previous water spillage and leakage either in the balcony or in the landing deck.
 - 3- Investigate for any problem or hidden damages which might have been the cause for the change in operational procedure of the entrance porch.
