ROOFING

ROOF COVERING

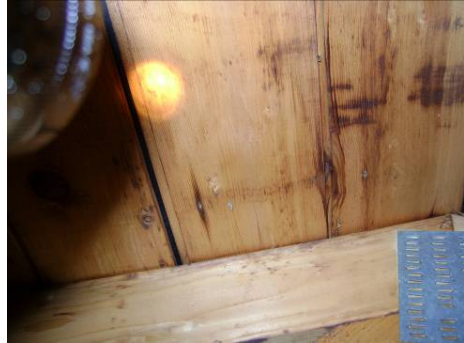
- Type: Roof covered with asphalt- shingle with a small portion of roll roofing over two added roofs over ground floor located on the sides of the north deck.
- Condition:
 - 1- Age of 1 to 5 years installed over lumber roof sheathing.

- *Recommendations:*
 - 1- Consult with RCABC for life expectancy and warranty for the roof due to its application over lumber roof sheathing.

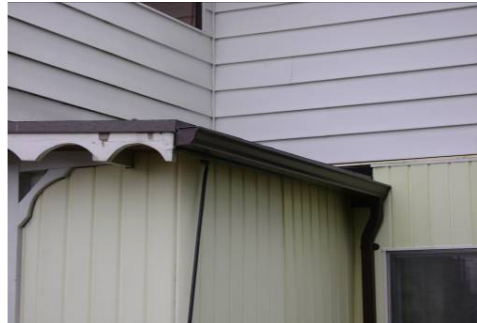
- 2- The roll roofing did not extend over the gutter for at least 1/2 inch to prevent water running under the roofing material.

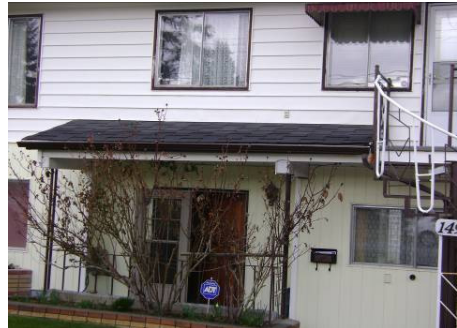
- Condition: The gutter on the entrance overhang (porch) was not sloped toward the down spot, and also there were stains on beam under the porch's gutter.
- *Recommendation:*
 - 1- Correct the slope in order to prevent over flow and fascia damage.
 - 2- Keep the gutters clean and free from debris for their proper operation.
 - 3- Inspect any hidden damages due to gutter's overflow on the beam under the porch.

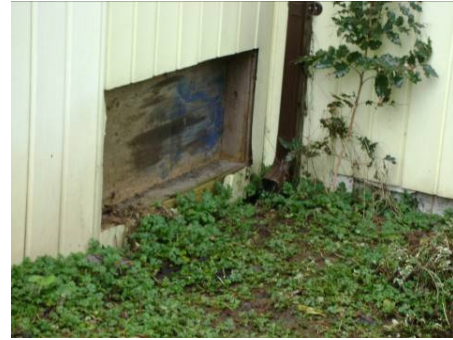
- Condition:
 - 1- The downspout in the north-west side discharges water close to the house.
 - 2- The downspout located at the west side of the entrance porch discharges water over the side-walk and close to the house.

- *Recommendations:*
 - 1- Extend the downspout to at least 6 feet from the house, or connect it to the drain-tile in order to prevent water penetration and damage to the house.
 - 2- Extend the downspout located beside the stair by a splash pan to the existing drain pit.
 - 3- Do in camera test for the continuity and condition of the downspouts.

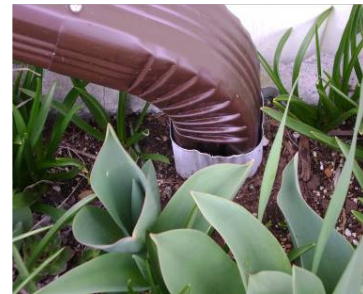
- 3- The metal downspouts in the south-west and north-west corners were extended into the soil (not passing through a PVC sleeve which could cause them to rust).

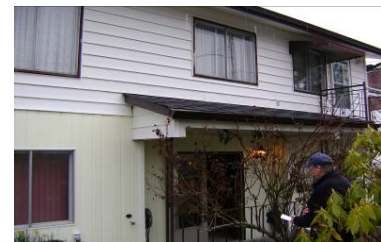
- Condition:
 - 1- The flashings between wall covering and the roof in the entrance overhang (porch) were missing.

- *Recommendation:*
 - 1- Install proper flashings in order to prevent any water migration behind the wall, roofing.
 - 2- Fix the chimneys flashings.

- 3- Inspect the building envelope for any hidden damages due to water ingress.

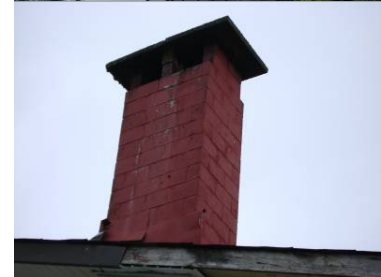
- 2- The counter flashings of the chimney on the west side were deformed and loose and in the south side were missing which could have caused water penetration to the roof sheeting.

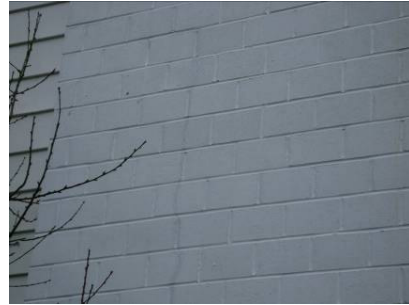
- Condition:
 - 1- There was a vertical crack on the chimney's wall either over the roof or on the wall below.
 - 2- The chimney cap was consisted of two parts which the mortar connecting them was worn out.
 - 3- The chimney cap did not have any drip and was not sloped toward the edges.
 - 4- The bricks supporting the cap or separating the flue lines had worn out mortars to the cap and in some parts to each other.
 - 5- The clean out can not be used for ground floor's fireplace due to its level.
- *Recommendations:*
 - 1- Slope the chimney cap toward outer edges.
 - 2- Install drip for the chimney cap in order to prevent water from the chimney walls.
 - 3- Fix the cap due to safety precautions; otherwise it may fall down in windy weather conditions.
 - 4- Check integrity of the chimney due to the mentioned deficiencies and safety by licensed structural contractor.
