STRUCTURE

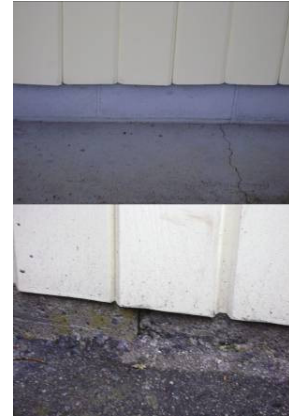
- Type: concrete block and slab on converted portion from carport to the occupational space on the east side and concrete for the other visible portions of the walls.
- Conditions:
 - 1- There were cracks on the east side supporting the east wall, and there is also cracks under the aluminum sliding over the concrete in the northern deck.
 - 2- There was not any foundation for the inside column located near the inside stairs.
 - 3- There were not any foundations visible for added metal posts in the north-east balcony.
 - 4- There were not any visible foundations for the south porch posts.

- ❖ ***Recommendation:*** Check all the aspects of the structural system for their integrity and safety use of the house by a licensed structural engineer or licensed structural contractor due to all the above mentioned deficiencies.

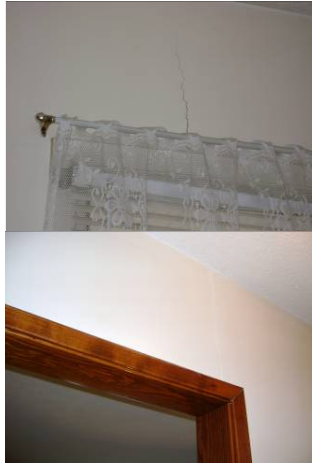
- 1- There were cracks over and under the window in the south wall, and also in the middle load bearing wall due to the settlement of walls.

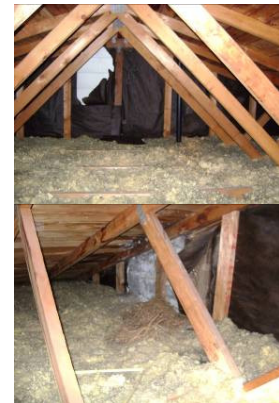
- Conditions:
 - 1- There were worn out and missing papers in the east and west wall.
 - 2- There was nest in the attic which showed either present or past animal activity in the attic.
