ELECTRICL SYSTEM

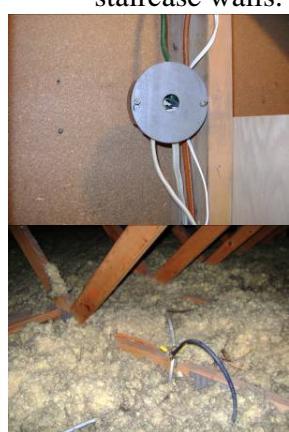
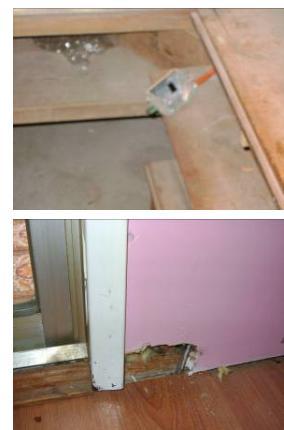
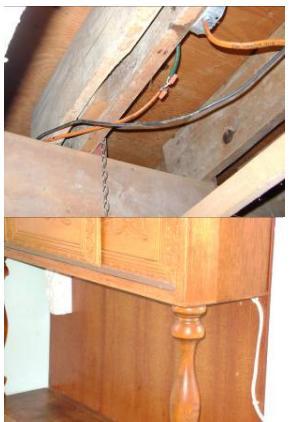
- Type: Copper
- Conditions:
 - 1- Added wire for lighting switch under the stair did not match the required ampere which would be a fire hazard issue.
 - 2- Added wire for the two installed outlets in the second floor bathroom did not match the required ampere which would be a fire hazard issue.

- 3- There were out of junction box connection of wires in the attic and under the ceiling of ground floor which could be a fire hazard issue.
 - 4- The wire connection for the ground floor exhaust fan did not match the required ampere and could be a fire hazard issue.

- 5- There was a loose junction box on the floor with no cap under the stair.
 - 6- There was not appropriate wiring (wiring under the roof joists or over wall covering) for locations such as: Under the ground floor ceiling and in the second floor room (room to the balcony), and a few other places.

- 7- There were loose wires passing under the beams and joists and under the staircase walls.

✤ Recommendation: Check all the aspects of the electrical system for their safety, fire hazard, shock hazard, and their proper operation by a licensed electrical contractor due to mentioned deficiencies. Also improve the accessibility of the panel and confirm the outside installation of the vacuum cleaner.

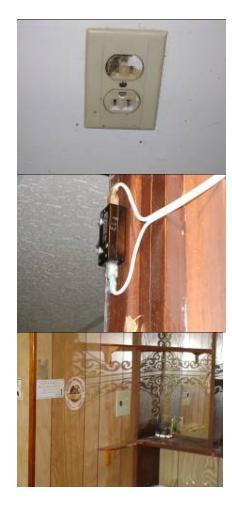
- 4- The outlet in the second floor corridor had broken cover which could cause a fire hazard.
- 5- The switch light and junction box used in the ground floor (under the staircase) are nonconforming type.
- 6- Two of the checked outlets had loose wire connections which could be a fire hazard (one in the ground floor close to the room and one in the second floor).

7- The outlets in the ground floor (under the staircase) and in laundry room did not have any cover which could lead to fire hazard issue.
