# INTERIOR

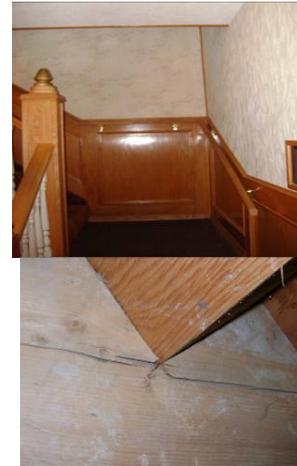
- **Condition:**
  - 1- The guard in the second floor (over the stair) is not appropriate due to height and loose connections which caused a safety issue.

1- Stair way does not have appropriate handrail (at the start of the stair) due to the height.

2- The height over the stair is less than the required one which caused a safety issue (1800 mm instead of 1950 mm).

3- Split in the stair's stringers along its longitudinal axes.

- **Recommendation:**
  - 1- Check the integrity and safe operation of the stairs by a licensed structural contractor.
  - 2- Fix all the other mentioned deficiencies.

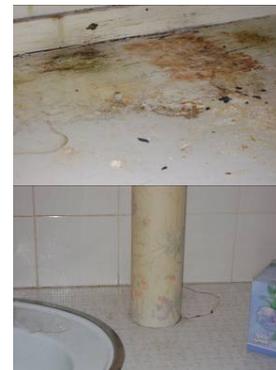
- **Cabinets:** The bottom part of the second floor toilet's cabinet was worn out due to water leakage.
- **Countertops:** The countertop in the ground floor's bathroom is broken.

- **Recommendation:** Change the damaged sections in the above mentioned places.
